DRAINAGE SYSTEMS AND ENGINEERING
MEASUREMENT DEVICES
ST. JOHNS BAYOU FLOODGATE, MISSOURI

TECHNICAL MEMORANDUM NO. 3-425

JANUARY 1956

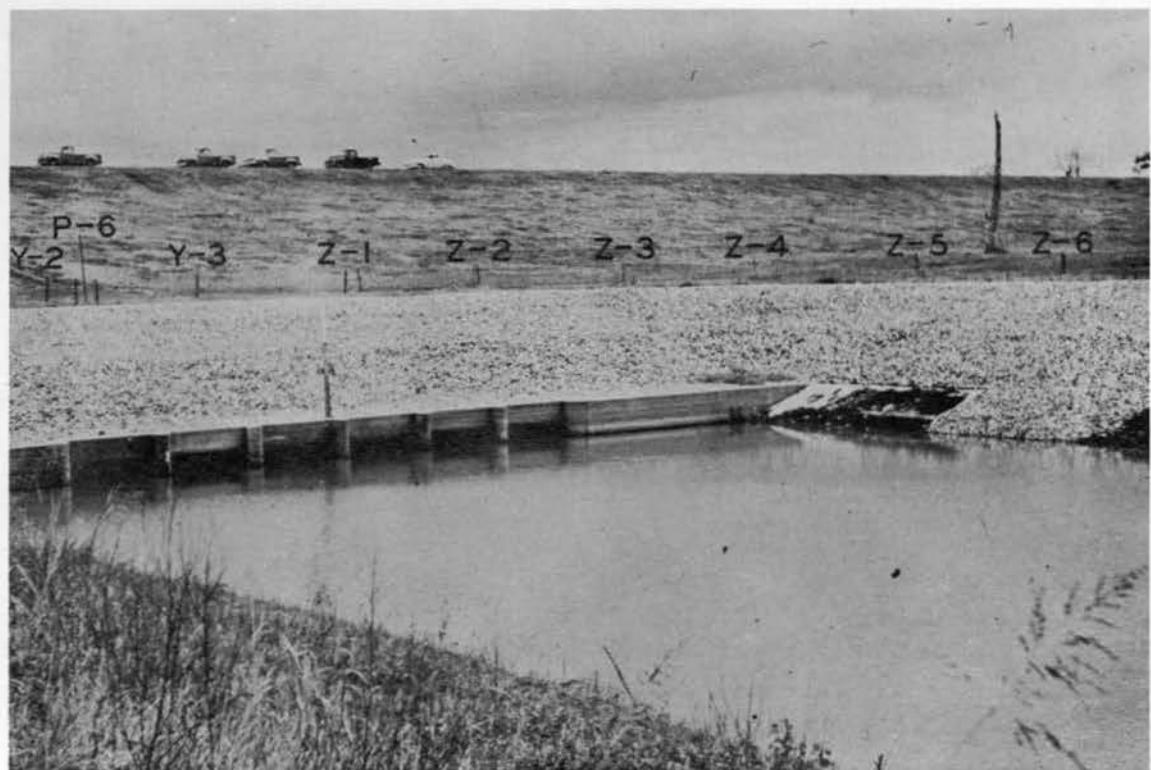
Fig. 5. Intake basin and Y and Z wells (July 1955)

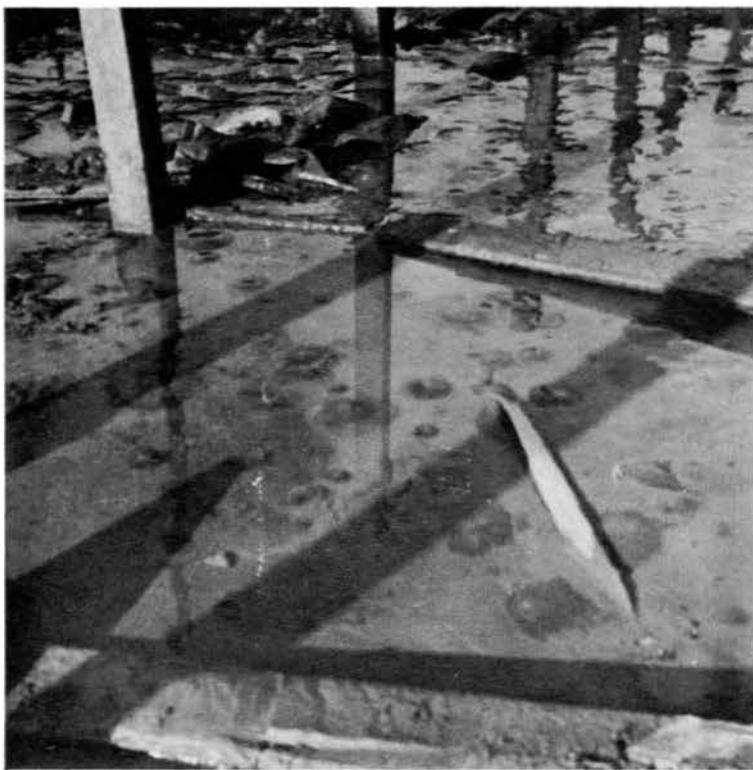
Numerous sand boils upstream of conduits (9 June 1951)

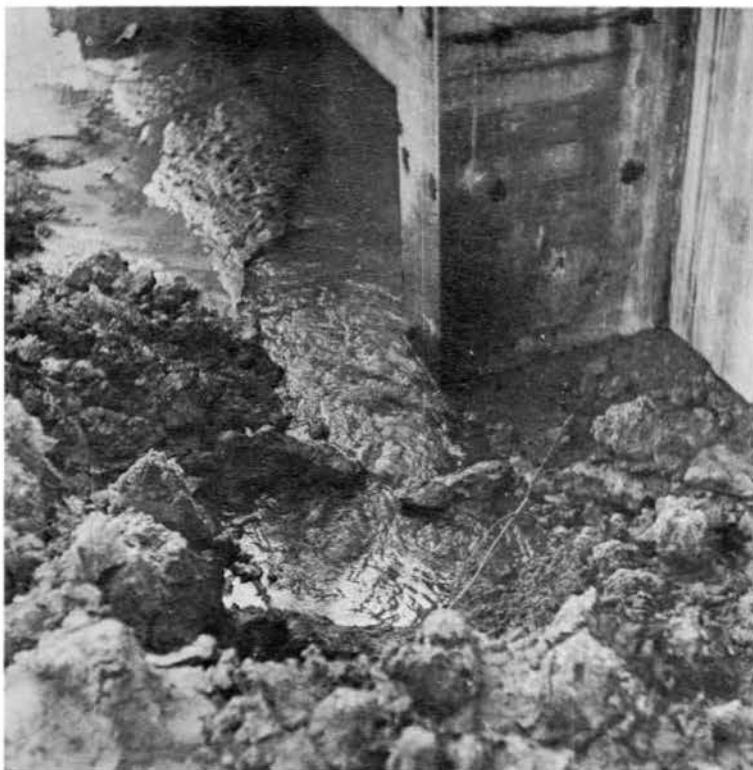
21. Piezometer 5 indicated an excess head of about 9 ft above the invert of the conduits. Although this head was not sufficient to raise the conduits, it caused seepage and sand boils along the edge of the structure, particularly at monolith 7 (see fig. 7).

Large boil along east side of conduits at monolith 7 (12 Dec 1951)

Fig. 7. Sand boils that occurred during construction of St. Johns Bayou floodgate

26. Elevations of the settlement hubs were obtained shortly after the hubs were installed and also in November 1952. The locations of the hubs and corresponding settlements are given in table 1. It is estimated that the fill was 75 per cent complete in November 1952. The amount of settlement is shown to be negligible except at monolith 7 (see fig. 1 for location) where approximately 1 in. of settlement was observed at hubs 3 and 3A. It is of interest to note that, as previously mentioned, a large sand boil was found in December 1951 on the east side of monolith 7 (see fig. 7(b)); this boil was estimated to be discharging approximately 150 gpm. The comparatively large settlement at monolith 7 might well have been caused by a void under the slab as a result of this sand boil.
